**DEPARTMENT OF TRANSPORTATION**

Contract #: 04-0120F4Cty: SF/ALA Rte: 80 PM: 13.2/13.9File #: 1.28**WELDING INSPECTION REPORT****Resident Engineer:** Siegenthaler, Peter**Address:** 333 Burma Road**City:** Oakland, CA 94607**Report No:** WIR-018599**Date Inspected:** 10-Dec-2010**Project Name:** SAS Superstructure**OSM Arrival Time:** 900**Prime Contractor:** American Bridge/Fluor Enterprises, a JV**OSM Departure Time:** 1730**Contractor:** American Bridge/Fluor Enterprises, a JV**Location:** Job Site**CWI Name:** William Sherwood**CWI Present:** Yes No**Inspected CWI report:** Yes No N/A**Rod Oven in Use:** Yes No N/A**Electrode to specification:** Yes No N/A**Weld Procedures Followed:** Yes No N/A**Qualified Welders:** Yes No N/A**Verified Joint Fit-up:** Yes No N/A**Approved Drawings:** Yes No N/A**Approved WPS:** Yes No N/A**Delayed / Cancelled:** Yes No N/A**Bridge No:** 34-0006**Component:** Orthotropic Box Girder**Summary of Items Observed:**

# WELDING INSPECTION REPORT

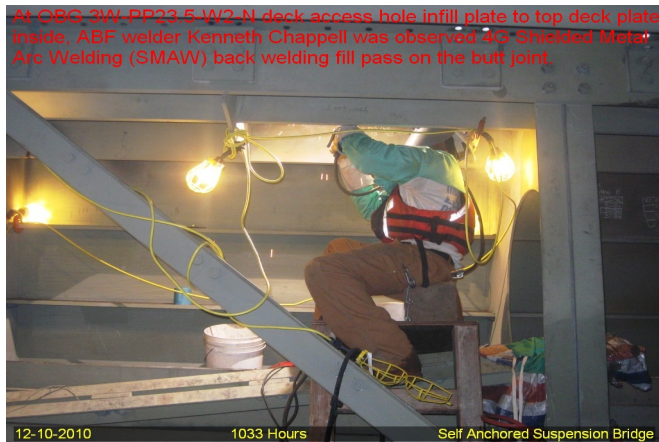
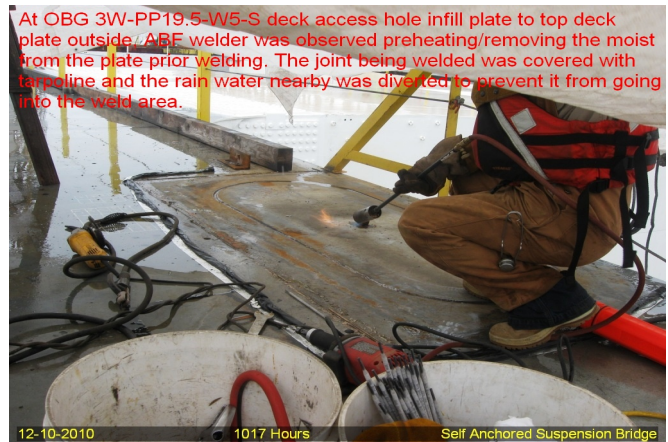
At OBG 3W-PP19.5-W5-S access hole infill plate to top deck plate outside, QA randomly observed ABF/JV qualified welder Mick Chan perform Complete Joint Penetration (CJP) groove fill pass welding. The welder was observed welding in the 1G (flat) position utilizing Shielded Metal Arc Welding (SMAW) with 1/8" diameter E7018H4R electrode implementing Caltrans approved welding procedure ABF-WPS-D15-1010 Revision 1. The joint being welded has a double V-groove butt joint. ABF Quality Control (QC) William Sherwood was noted monitoring the welding parameters of the welder. At the end of the shift, fill pass welding of the butt joint at location mentioned above was still continuing and should remain tomorrow.

At OBG 3W-PP23.5-W2-N deck access hole inside, QA randomly observed ABF/JV qualified welder Kenneth Chappell continuing to perform fill pass back welding on the CJP butt joint. The welder was observed manually welding in the 4G (overhead) position utilizing a SMAW with 1/8" diameter E7018H4R electrode and implementing Caltrans approved WPS ABF-WPS-D15-1010 Revision 1. The joint being welded has a double V-groove butt joint welded with open root from the top deck. ABF Quality Control (QC) William Sherwood was noted monitoring the welding parameters of the welder. At the end of the shift, SMAW fill pass welding was still continuing and should remain tomorrow.

Yu continuing to perform fill pass back welding on the CJP butt joint. The welder was observed manually welding in the 4G (overhead) position utilizing a SMAW with 1/8" diameter E7018H4R electrode and implementing Caltrans approved WPS ABF-WPS-D15-1010 Revision 1. The joint being welded has a double V-groove butt joint welded with open root from the top deck. ABF Quality Control (QC) William Sherwood was noted monitoring the welding parameters of the welder. At the end of the shift, SMAW fill pass welding was still ongoing and should continue tomorrow.

At OBG 6W-PP46.5-W5-S access hole infill plate to top deck plate outside, QA randomly observed ABF/JV qualified welder Jorge Lopez continuing to perform CJP groove fill pass to cover pass welding. The welder was observed welding in the 1G (flat) position utilizing SMAW with 1/8" diameter E7018H4R electrode implementing Caltrans approved welding procedure ABF-WPS-D15-1010 Revision 1. The joint being welded has a double V-groove butt joint. ABF Quality Control (QC) William Sherwood was noted monitoring the welding parameters of the welder. At the end of the shift, cover pass welding of the butt joint at location mentioned above was still continuing and should remain tomorrow.

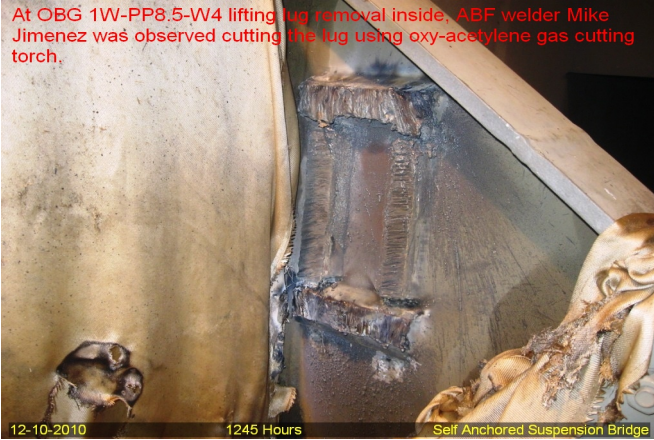
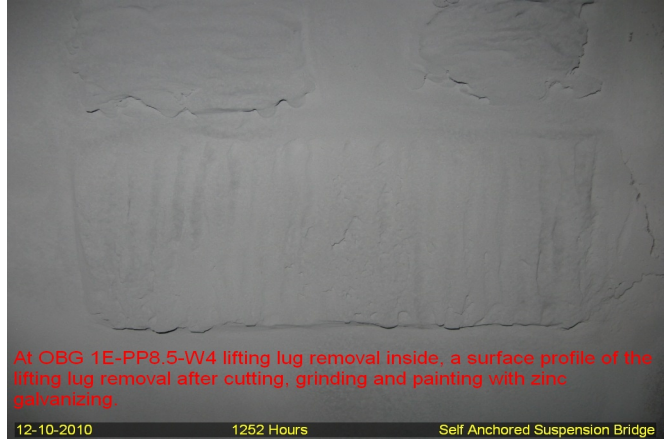
At OBG 1W-PP8.5-W4 inside, QA randomly observed lifting lug bracket removal per Request For Information (RFI) ABF-RFI-001151R01. During the observation, it was noted that the lifting lugs were removed using the oxy-acetylene gas torch and the remnants of it were cut further using carbon air arc gouging (up to 1/4" left after cutting). Even after grinding, remnants were still noted with square cut and not smoothly ground. There was no 1:3 transition on the cut corners as required in the submitted/approved RFI. After grinding, the lifting lug removal was painted using the Aervoe zinc rich galvanizing spray which the ABF foreman Rick Clayborn said was just temporary. It was noted that the lifting lug removal was not done per RFI ABF-RFI-001151R01. When QC was asked concerning this lug removal, Bonifacio Daquinag informed this QA that they never got involved with it due to lack of information (QC were not told about the work and not received the RFI). At the moment, all four lifting lugs at the eastbound were already cut and painted while two were cut but only one was painted at the westbound. Two more lifting lugs at the westbound need to cut.

At OBG 1W-PP8.5-W4 lifting lug removal inside, ABF welder Mike Jimenez was observed cutting the lug using oxy-acetylene gas cutting torch.
